**HORNSEY BROTHERS DAM
WASHINGTON COUNTY, MISSOURI
MO 30101**

PHASE 1 INSPECTION REPORT NATIONAL DAM SAFETY INSPECTION

NOVEMBER 1980

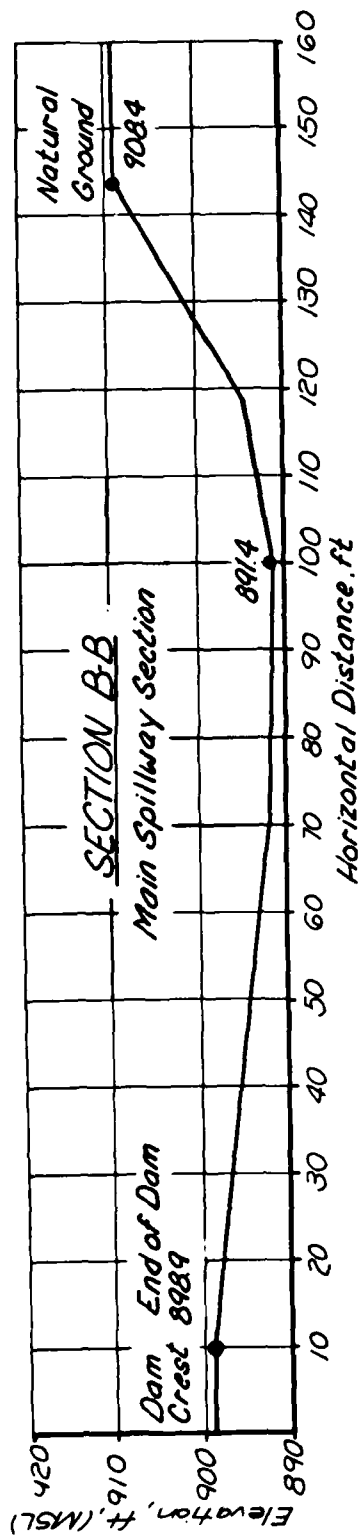
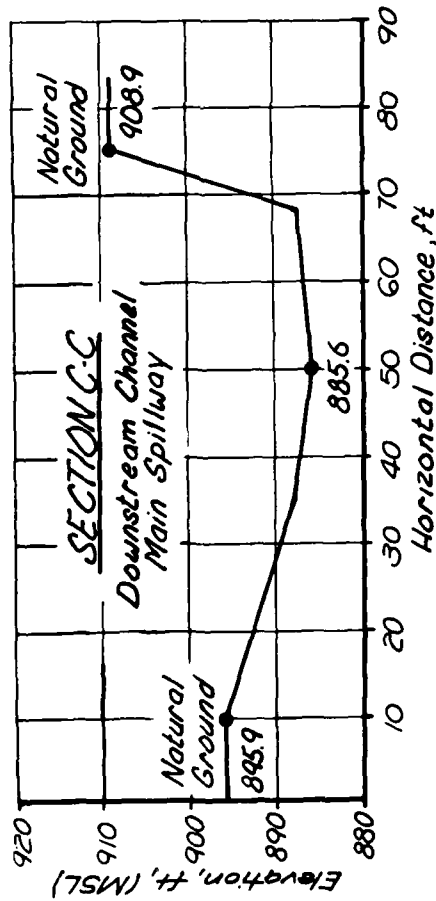
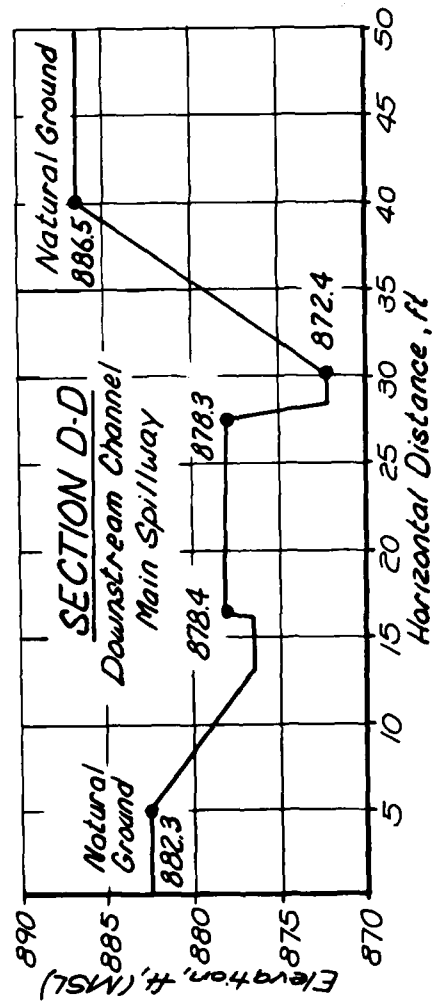
Fig. 3-B

3. Spillway. The ungated main spillway is located on the right abutment of the dam. The spillway and discharge channel were constructed by blasting the natural rock formation. The spillway shape is approximately trapezoidal. Because of the steepness of the discharge channel, cross-section B-B of the main spillway (Fig. 3B) acts as the control section for discharge.

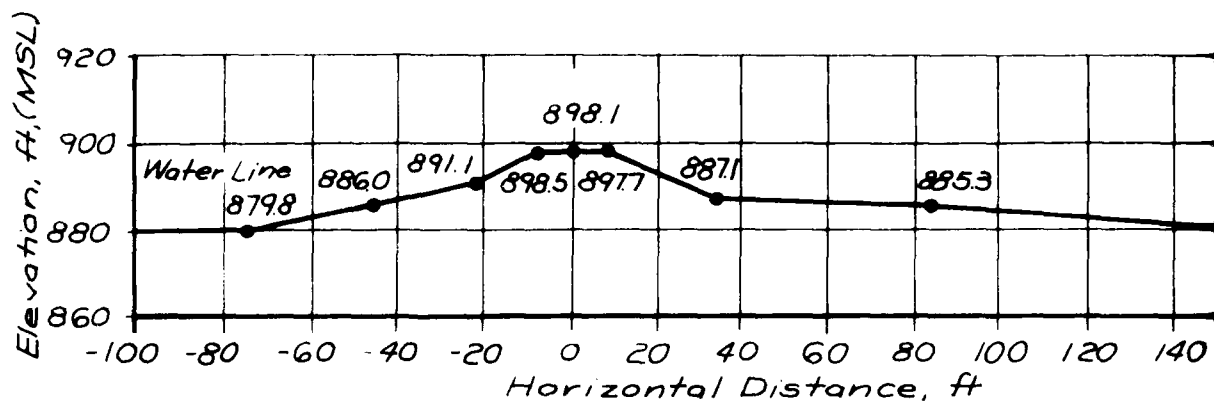
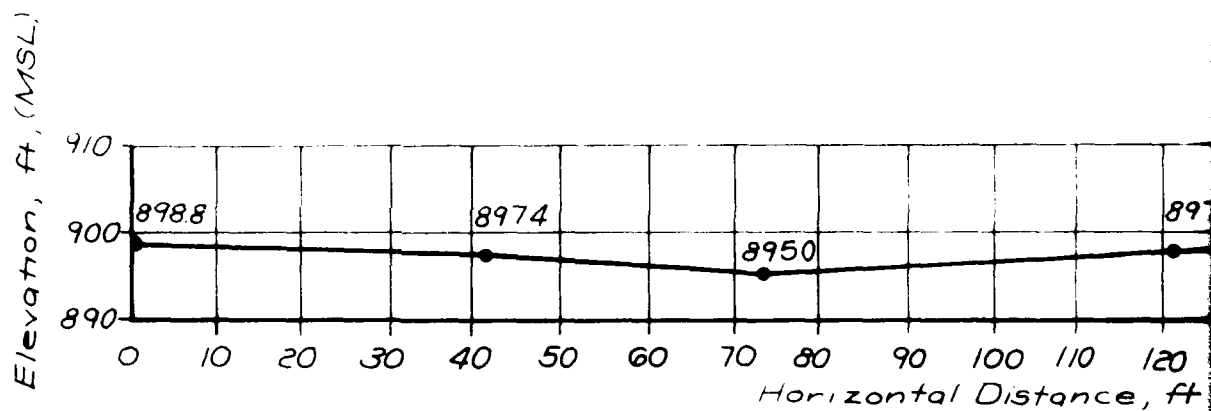
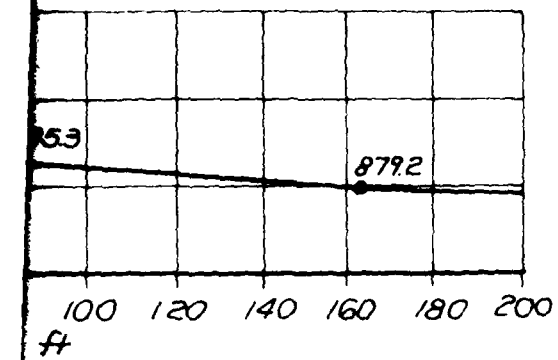
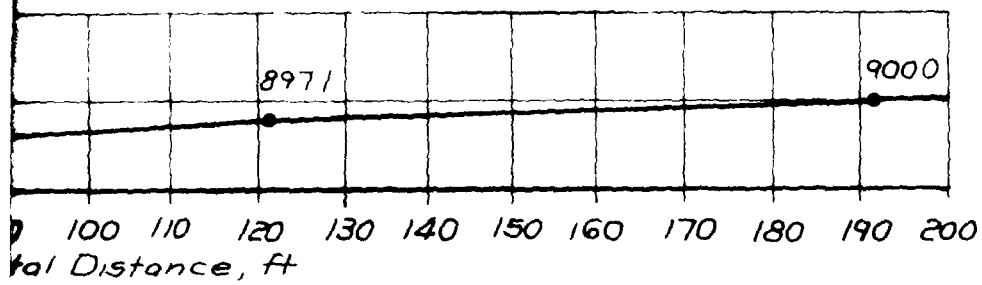
Fig. 3-C

An auxiliary spillway located at the left abutment (Overview Photo) consists of a low berm adjacent to the west end of the dam embankment, approximately 4 ft above the level of the main spillway and about 3 ft lower than the main embankment of the dam. Discharge from this spillway would flow near the toe of the dam, but would not be confined by any existing channel. The valley sides slope down toward this auxiliary spillway, and do not allow for unrestricted flow over the entire length of this low berm. Detailed surveying and backwater hydrologic analysis are beyond the scope of this Phase I study. However, four cross-sections perpendicular to the axis of the low berm have been surveyed and an approximate profile of the effective auxiliary spillway has been constructed and is shown in Fig. 3-C. There is no record of flow over the auxiliary spillway to date.
